amcor

October 11, 2022

Dear Valued Parafilm Customer,

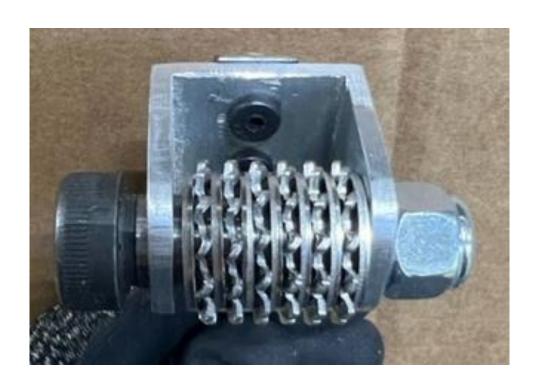
Tail Wipe Mechanism

Recently our Parafilm operation has been upgraded from a manual process to an automated solution. The noticeable change in appearance, largely at the top of each roll, is due to our tail wipe system. As the rolls are taken off the line the unsecured end, or tail, must be secured for it to feed down our packaging line. To secure the tails, the finished rolls are spun against a stationary piece with free spinning indentation wheels while light pressure is applied. While this secures the tails, it also causes a visual marking on the material.

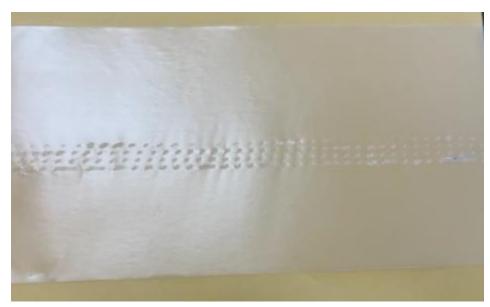
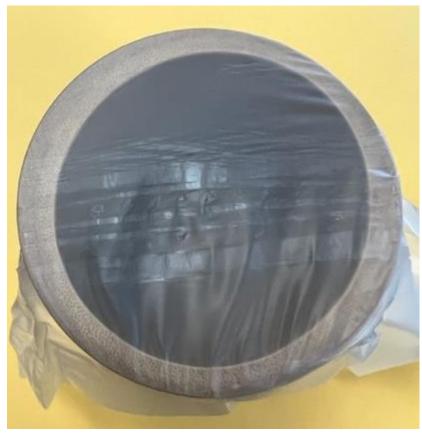
Top of Roll

Past potentially the first wrap, this marking will be purely a visual defect and will not affect the functionality of the film. The pressure applied is not great enough to puncture the Parafilm to the point where functionality is affected past the first wrap.
